**BOTANICAL STATEMENT FOR A PROPOSED TRAFFIC CIRCLE AT THE  
INTERSECTION OF BADEN POWELL (R310) AND MACASSAR ROAD  
(M9) WITHIN THE CITY OF CAPE TOWN MUNICIPALITY**

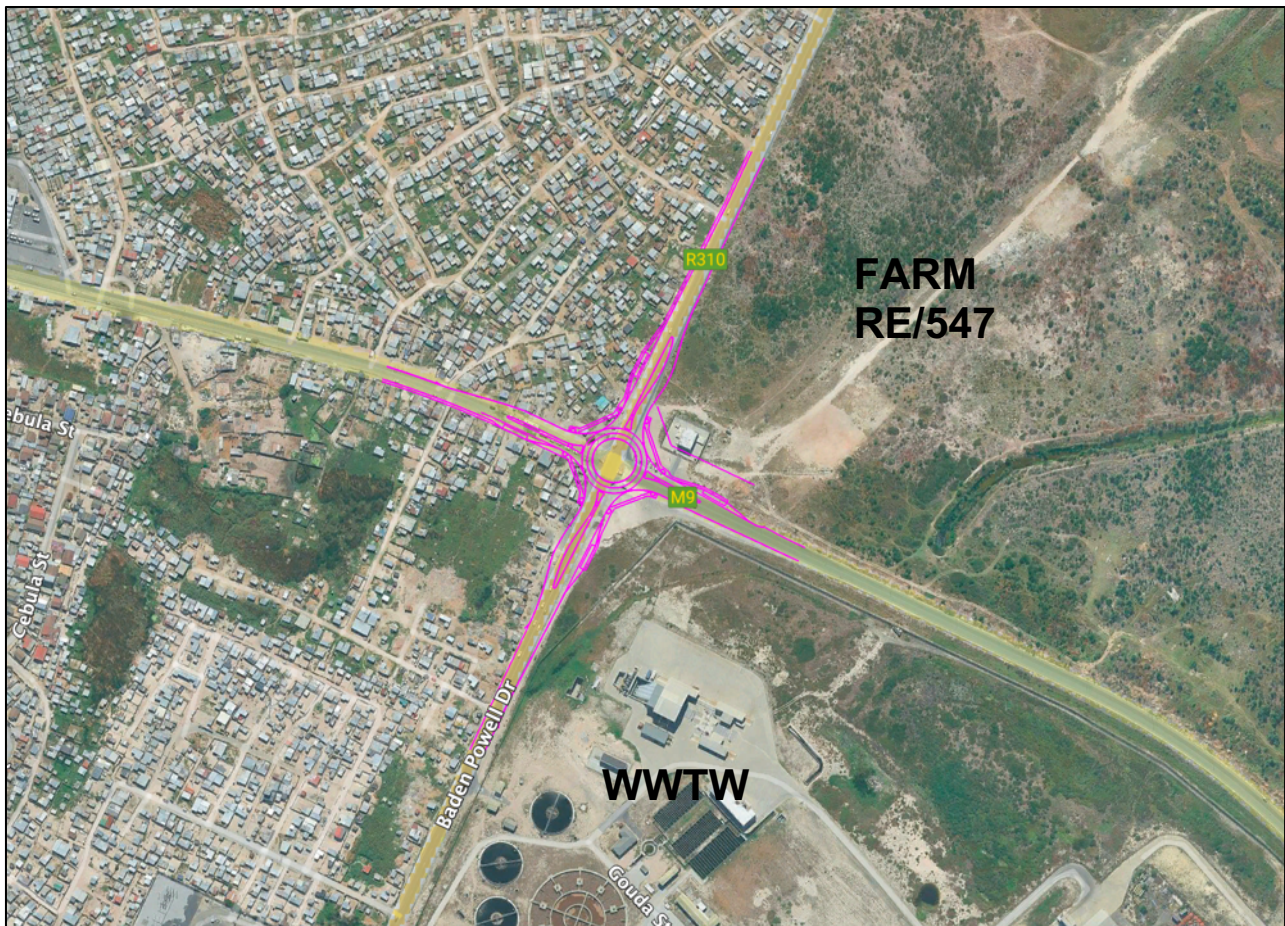
**Figure 1.** The design of the proposed traffic circle (pink lines) in relation to the surrounding areas. The suburb to the west of the circle is Khayelitsha.

A traffic circle has been proposed at the intersection of Baden Powell Drive and Macassar Road. The road upgraded has been proposed in an area adjacent to some indigenous vegetation, and may result in the loss of indigenous vegetation. The Environmental Assessment Practitioner (EAP) for the project is The Environmental Partnership (TEP). The EAP commissioned Capensis Ecological Consulting (Capensis) to provide a botanical statement on the proposed road upgrade, as the author was the botanical specialist for a project on the adjacent property. This statement is based on the work undertaken on the adjacent property for a proposed development on Farm RE/547, located on the north-east quadrant of the traffic circle. No fieldwork has been undertaken to inform this statement, only desktop information has been used. The proposed traffic circle location is displayed below in Figure 1.

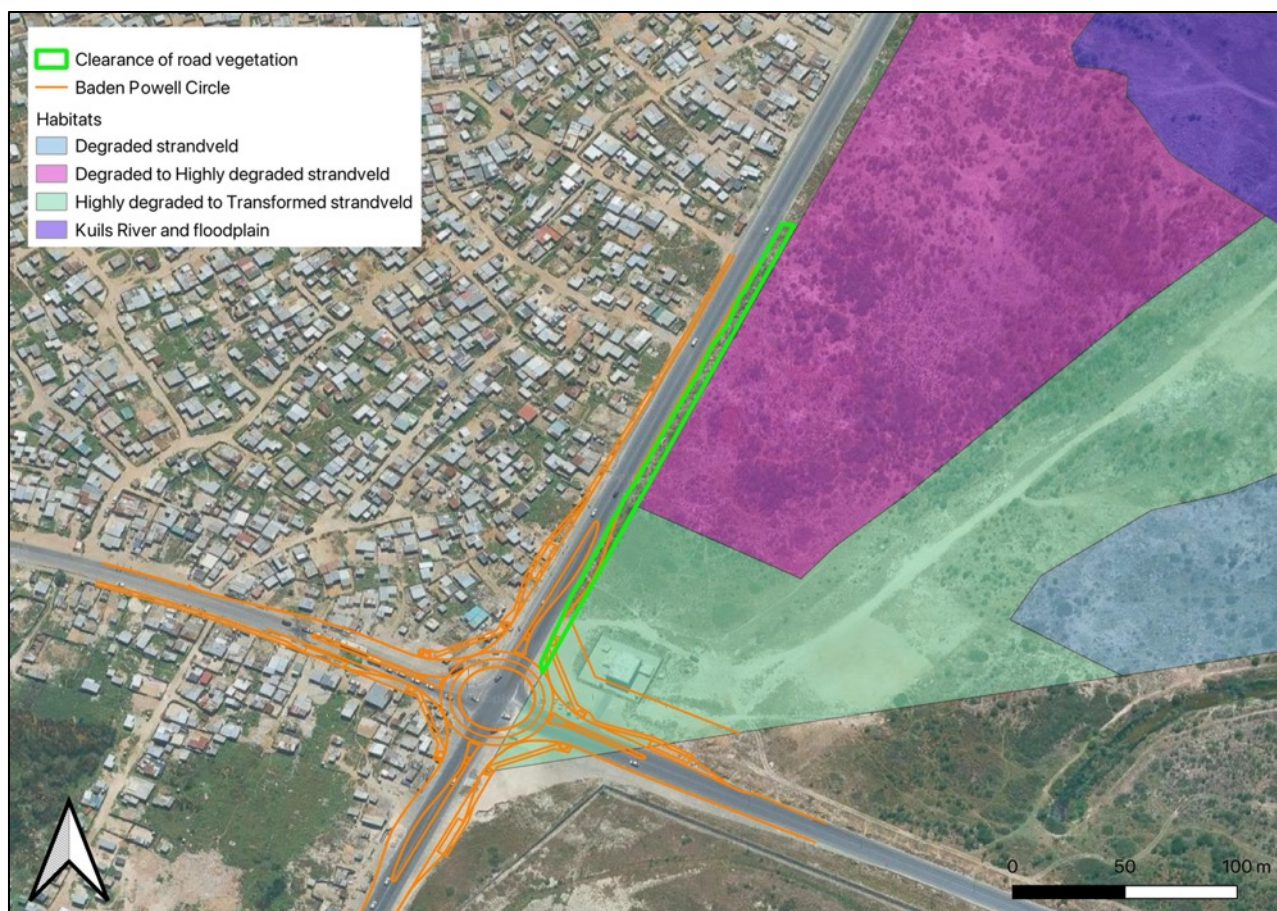
**Figure 2.** The habitats mapped on Farm RE/547 in relation to the proposed traffic circle and the likely area that will be cleared, overlaid on a Google Earth™ aerial image.

The vegetation in the areas adjacent to the proposed works in the road reserve was classified as (1) Degraded to Highly degraded Strandveld and (2) Highly degraded to Transformed Strandveld (Figure 2) in the botanical report for Farm RE/547 (Nicolson, 2022). The Degraded to Highly degraded strandveld habitat is “indigenous vegetation” according to the legal definition. The Departments and Environmental Affairs and Development Planning (DEA&DP) defines indigenous vegetation as: “...vegetation consisting of indigenous plant species occurring naturally in an area, regardless of the level of alien infestation and where the topsoil has not been lawfully disturbed during the preceding 10 years.”<sup>1</sup>

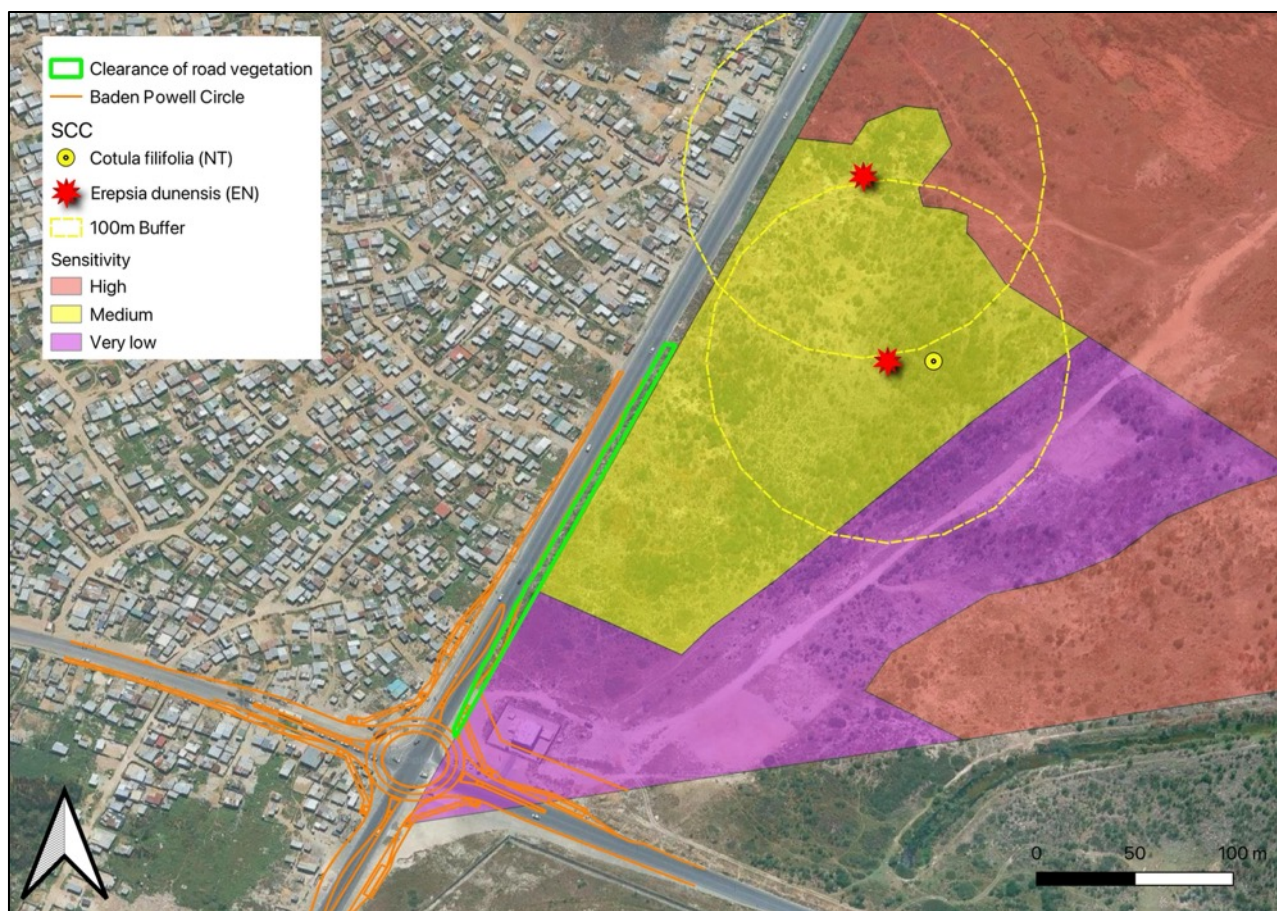
**Figure 3.** The sensitivity map and SCC on Farm RE/547 in relation to the proposed traffic circle and the likely area that will be cleared, overlaid on a Google Earth™ aerial image.

The sensitivity of the habitat adjacent to the areas proposed for clearing are (1) Medium and (2) Very low. One species of conservation concern was found in previous studies in the adjacent property in the vicinity of the proposed works, but the buffer around this species does not intersect with the proposed works (Figure 3).

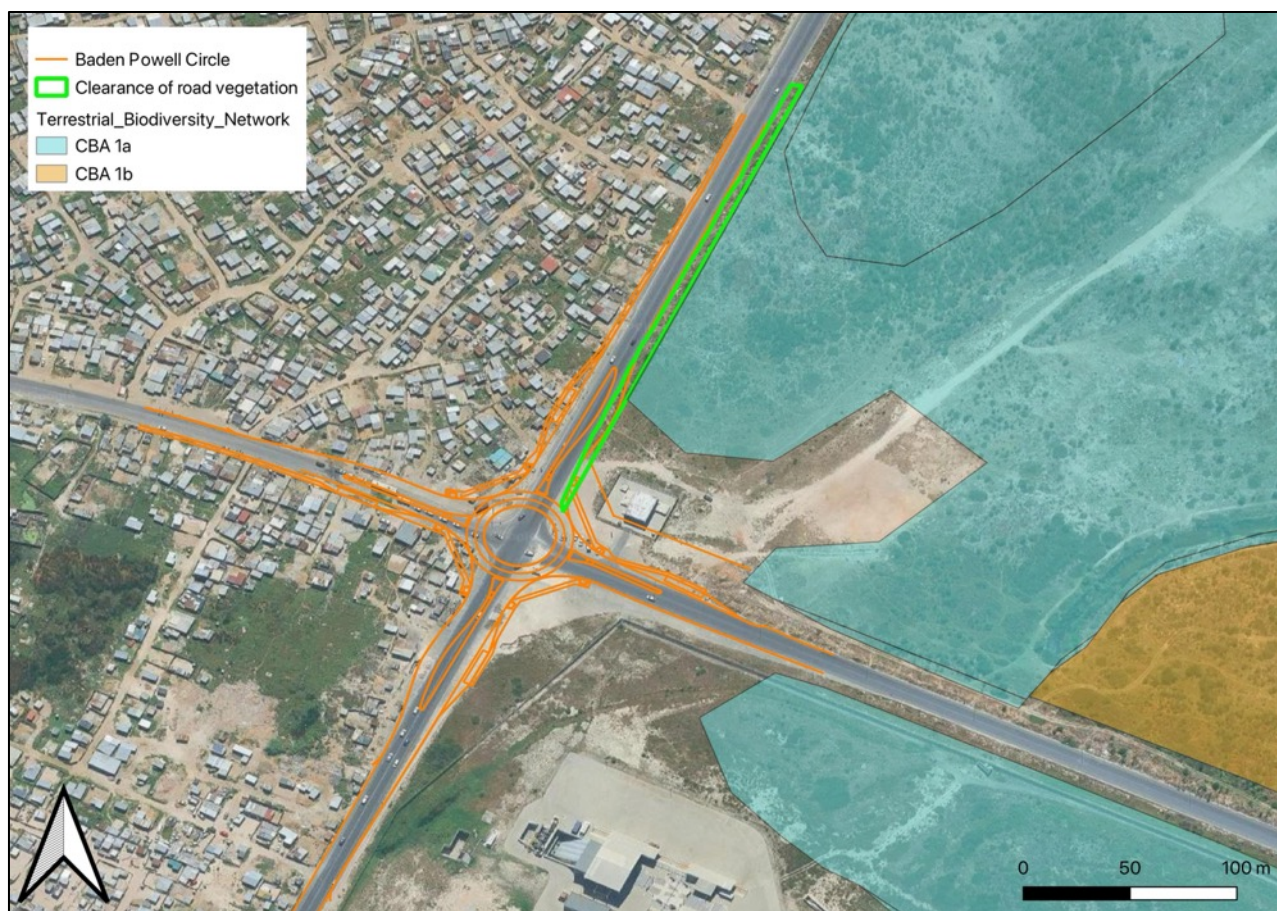
**Figure 4.** The COCT TBN Map for the site and on Farm RE/547 in relation to the proposed traffic circle and the likely area that will be cleared, overlaid on a Google Earth™ aerial image.

The area likely to be cleared for the new traffic circle is excluded from the 2024 Terrestrial Biodiversity Network (TBN) (City of Cape Town, 2024). This supports the idea that the vegetation within the road reserve has not been seen as a conservation priority. The adjacent area in Farm RE/547 is classified as CBA 1a (Figure 4). This is an important area and according to the TBN, CBA1a sites are considered to be 100% irreplaceable.
